**MARINE CASUALTY INQUIRY REPORT**

**Collision between M.V. PAPU and C.S. NIWA**

**Date of Casualty:** on 28 May 2026 at 1950 PST (Pakistan Standard Time- UTC + 5 Hrs.)

**Location:** Approaches to Karachi Port, Pakistan

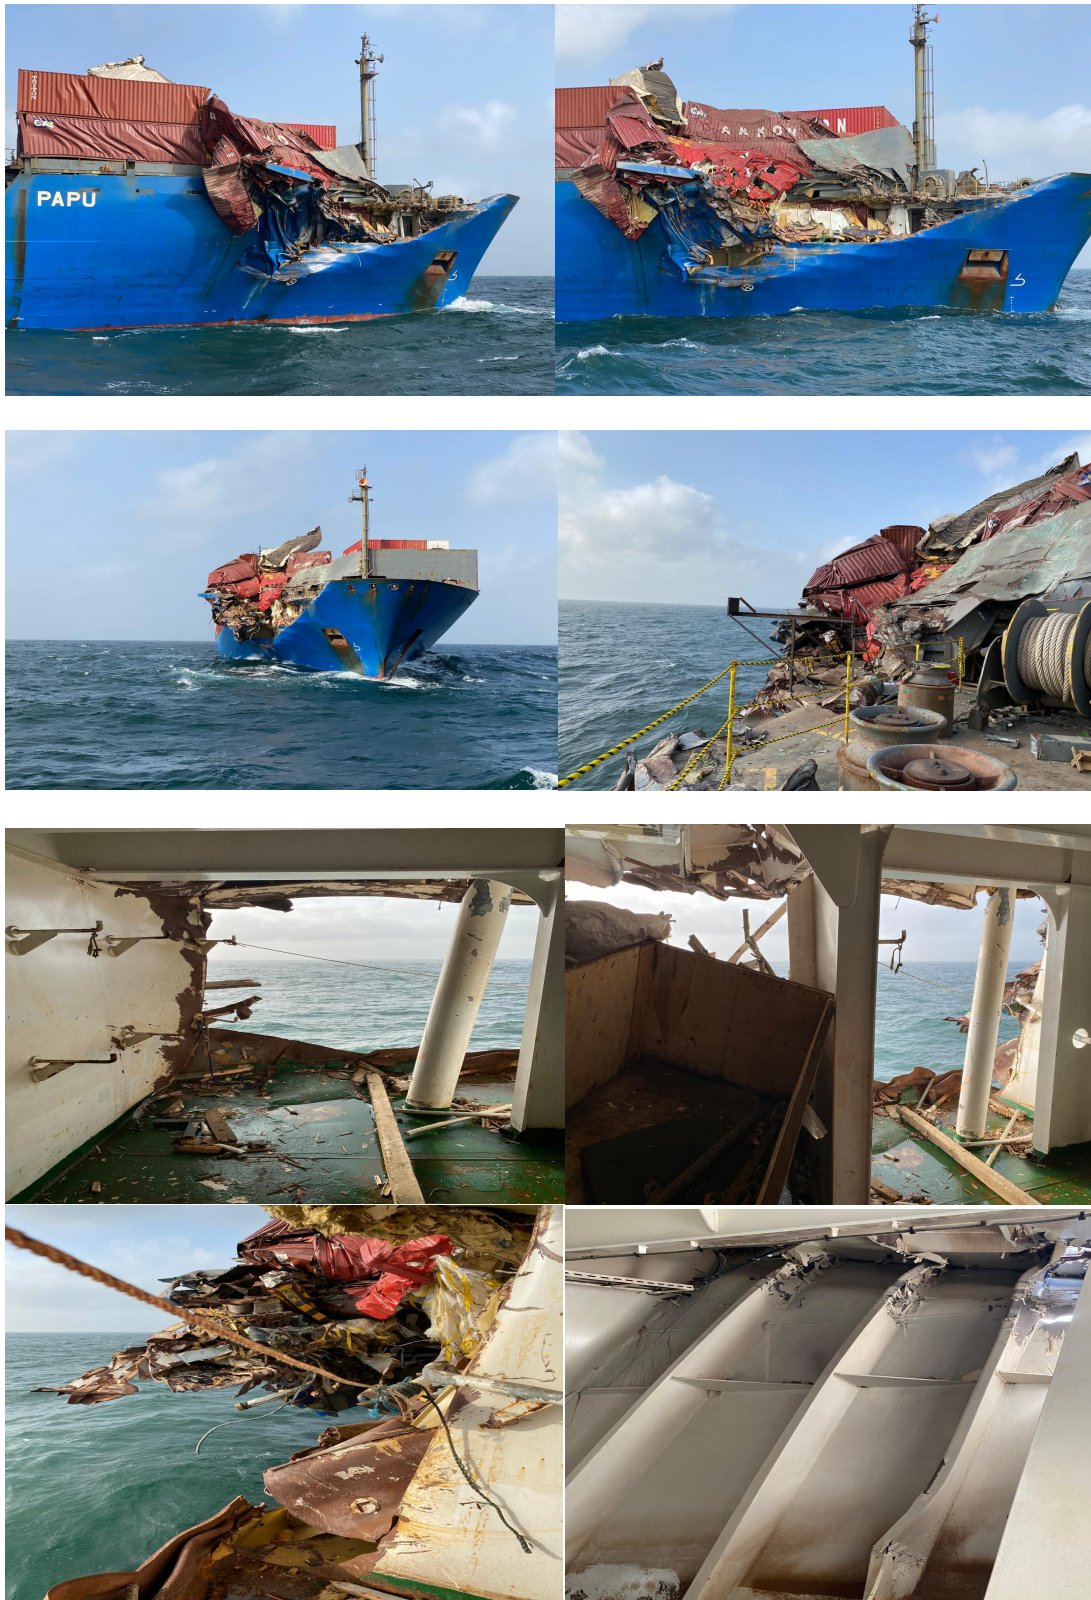
Photos Of Papu After Collision With Cable Ship NIWA

**M.V. PAPU:** Damaged on starboard bow area

Hull breach damage **above the water line** on starboard bow area

No water ingress, no ballast tanks damaged

Temporary repairs completed as per class requirements

Flag administration granted one voyage dispensation to Türkiye for permanent repairs

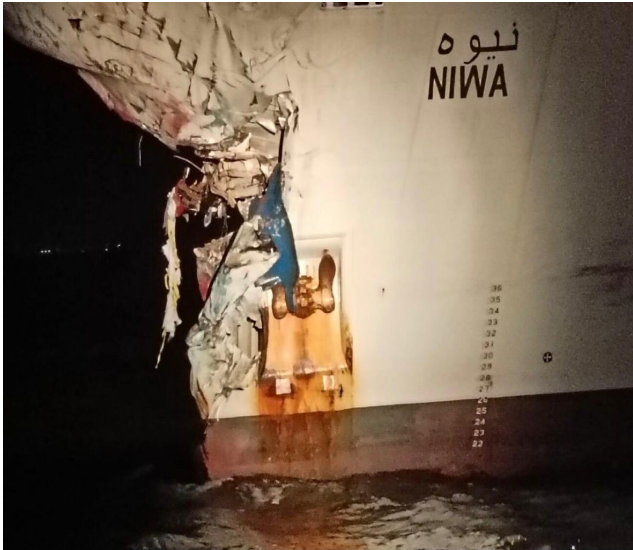
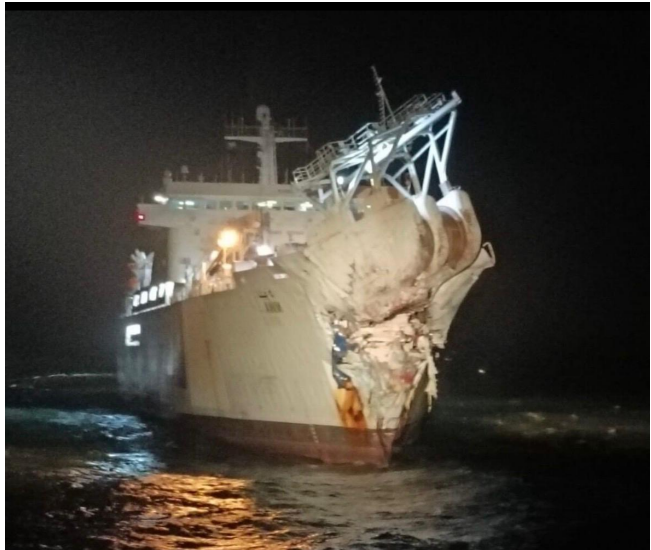
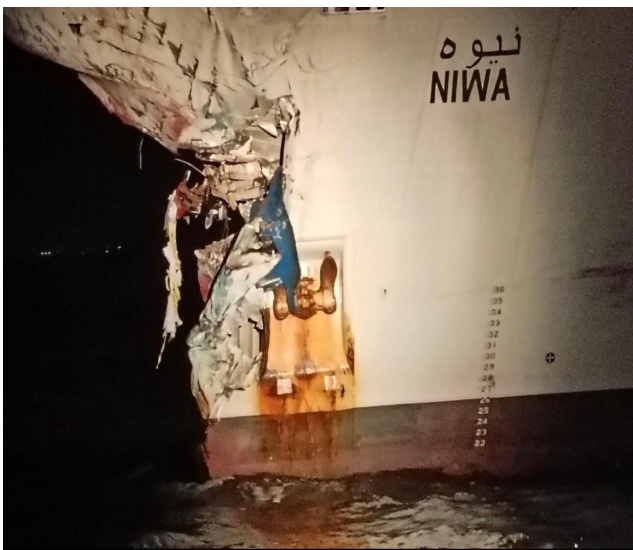
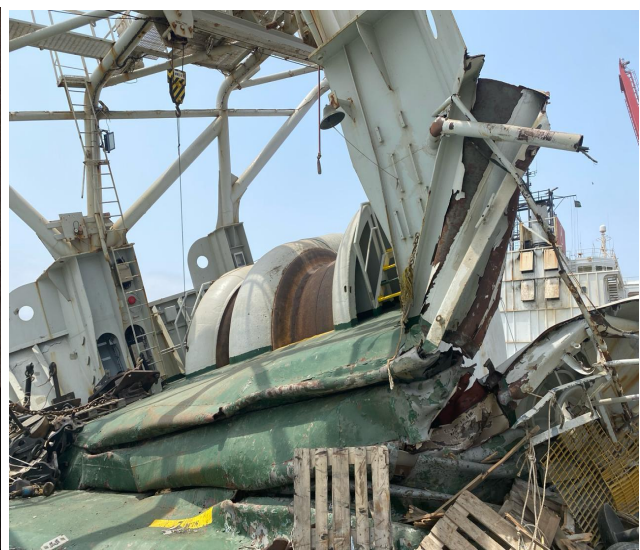
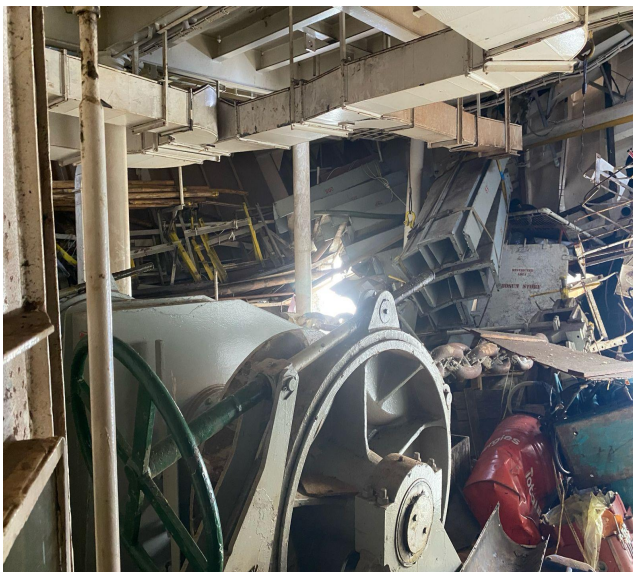
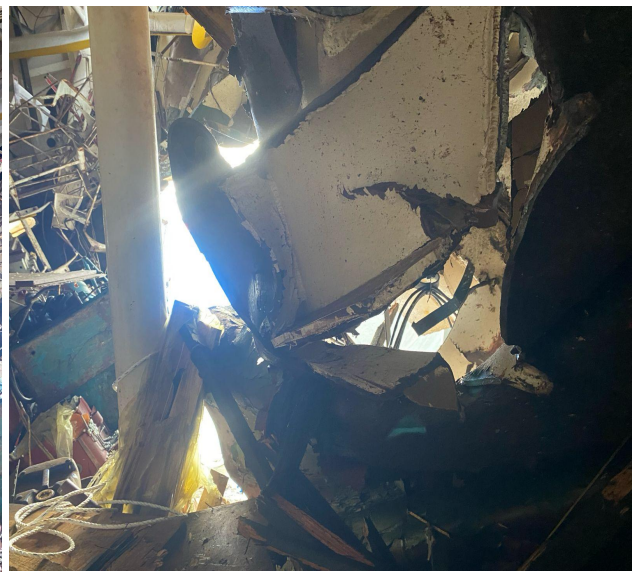
Photos of Cable Ship NIWA after Collision with Container Ship M.V PAPU

**C.S. NIWA:** Damaged on forward port & Stbd bow area (Frame 160 to Frame 220)

Port Side: Frame No. 185 to 220 (Extensive Damage)

Starboard Side: Frame No. 180 to 220 (Extensive Damage)

Frame No. 160 to 180: Damage to Shell Plating & Structure

Extensive collision damage to forward section between **Frame No. 160 and Frame No. 220:**

Multiple shell plates fractured and folded inward

Frames, web structures, brackets, stiffeners, bulkheads damaged

Collision bulkhead fully damaged
